Manhole Inspection Summary

Manhole # S33E__012MH

Location Address: **225 liberty st**

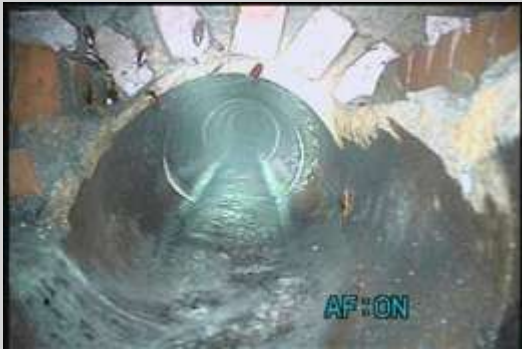
12 O'Clock Outflow

10 in. Circular Gravity Sewer
Pipe Out @ 12 O'Clock

Pipe Material: **Clay** ☐ Pipe Lined

Invert Depth: **17.80** (ft.) Flow Characteristics: **Fast**

Infiltration: **None** Pipe Seal Cond: **Unknown**

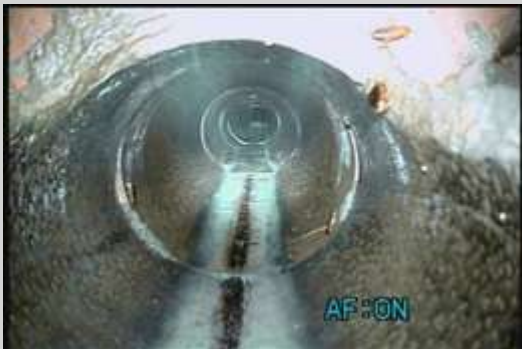
6 O'Clock Inflow

10 in. Circular Gravity Sewer
Pipe In @ 6 O'Clock

Pipe Material: **Clay** ☐ Pipe Lined

Invert Depth: **17.70** (ft.) Flow Characteristics: **Fast**

Infiltration: **None** Pipe Seal Cond: **Unknown**

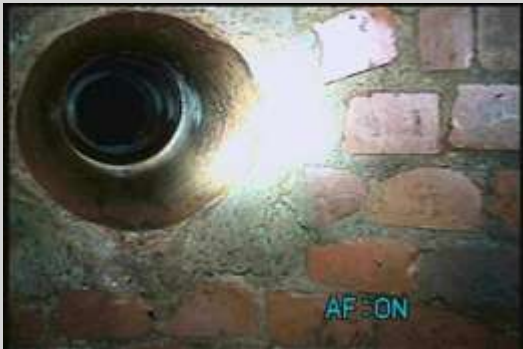
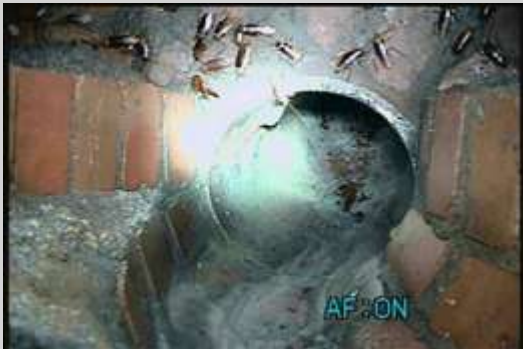
9 O'Clock Inflow

8 in. Circular Gravity Sewer
Pipe In @ 9 OClock

Drop In @ 9 OClock

Pipe Height: 0 (in.) Direct
Pipe Material: Clay ☐ Pipe Lined
Invert Depth: 13.50 (ft.) Flow Characteristics: Fast
Deposits: ☒ None ☐ Mud ☐ Sludge ☐ Debris ☐ Grease
Silt Depth: 0 (in.) Deposits Extent:
Infiltration: None Pipe Seal Cond: Unknown

Drop: Outside	Direct
Angled:	Reading: 0.00 (ft.)
	Inv Depth: 17.50 (ft.)
Drop Condition: Open
